Dangerous geological processes on Lake Kolsai and the impact of Anthropogenic load on the DGP

M.R. Zapparov¹, M.K. Kasenov², E.S. Auelkhan^{1*}, B.T. Serikov¹, S.N. Nurmukhanbet¹

¹Satbayev University, Almaty, Kazakhstan

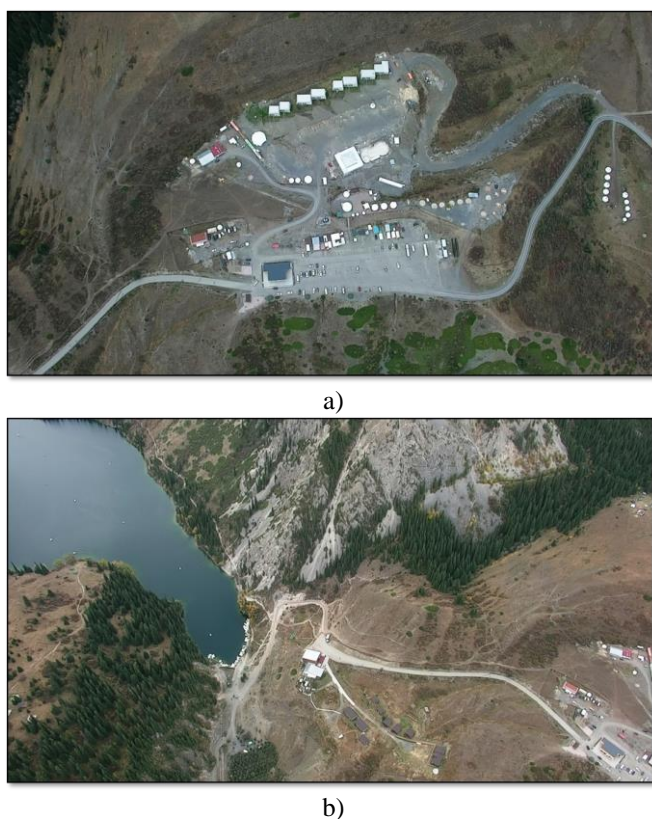
On the body of the landslide and in the erosion focus there is a large anthropogenic load which is expressed in the construction of houses and buildings, the lack of a unified sewerage system, the construction of swimming pools, the lack of supply and discharge structures, sealed containers for wastewater, toilets, etc. (Figure 2, a,b).

Figure 2. Structure on the erosion focus (picture from UAV)

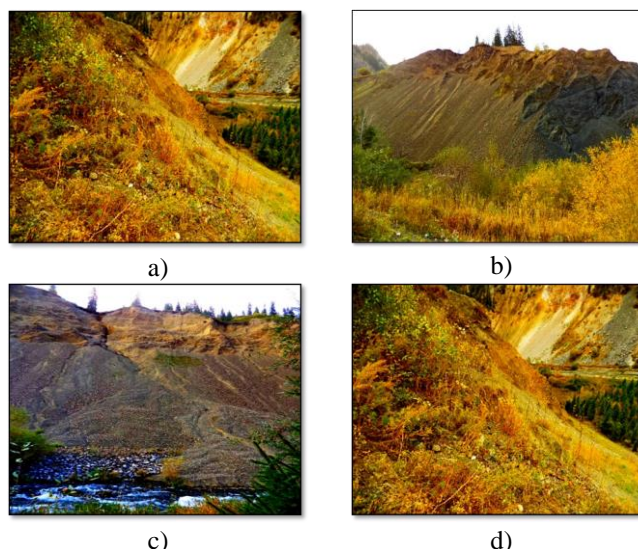
Along the edge of the left-bank slope at a distance of 0.2...0.3 m, the presence of shallow separation cracks 1...3 cm wide was revealed.

The crumbling process will continue until the formation of a natural slope of the soils that form the plumes of talus. Depending on the intensity and amount of precipitation, melting snow, this process can take about 3-7 years. Presumably, the edge of the erosion incision will move towards the technogenically loaded territory by another 30-40 meters. Also, on the port side on the body there are wedgings of groundwater with insignificant expenses due to precipitation. (Figure 3, a-d).

Figure 3. Photographic materials of landslide-prone areas on the territory of the State National Natural Park "Kolsai Lakes" of Almaty region (September 28-29, 2022): (a) – Portside. Slopes below the water intake 70 m; (b) – Portside. Slopes below the water intake 150 m; (c) – Portside. Water-erosion incision and alluvial fan displacing the water flow of the Kolsai River (≈ 200 m below the intake); (d) – Portside. Separation crack below water intake 60 m.

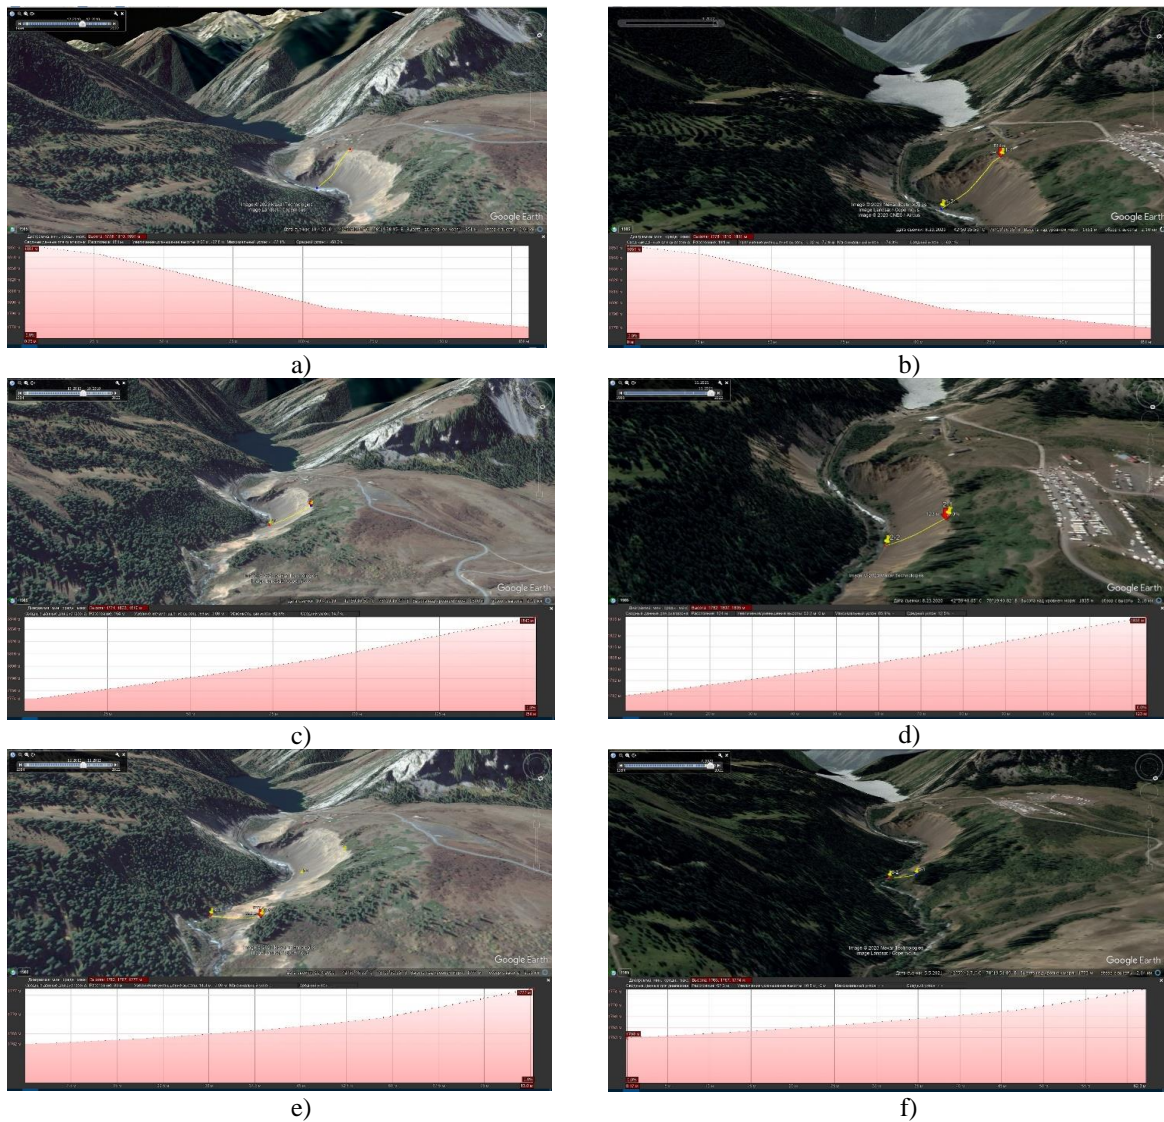
At the time of writing this article, using the Google Earth Pro program, space images were taken from the LandSat-7, 8 satellites, taken in 2010 and 2021. An analysis was carried out for changes in the dimensions of the port side, comparisons were made at 3 identical points, graphical examples of these analyzes are given in the appendices (Figure 4, a-f). According to the data obtained, it can be noted that during the taken period of time the following details are noted:

- Significantly increased anthropogenic and technogenic pressure on the left side of Lake Kolsai.
- There are noticeable changes in the shape, steepness and size of the port side.

Figure 4. Space images of landslide-prone areas on the territory of the State National Natural Park "Kolsai Lakes" of Almaty region: (a) – the first profile of the relief of the left side of the Kolsai River (space image of 2010); (b) – the first relief profile of the left bank of the Kolsai river (space image 2021); (c) – the second relief profile of the left side of the Kolsai river (space image of 2010); (d) – the second relief profile of the left side of the Kolsai river (space image 2021); (e) – the third relief profile of the left side of the Kolsai river (space image 2010); (f) – the third relief profile of the left side of the Kolsai river (space image 2021)

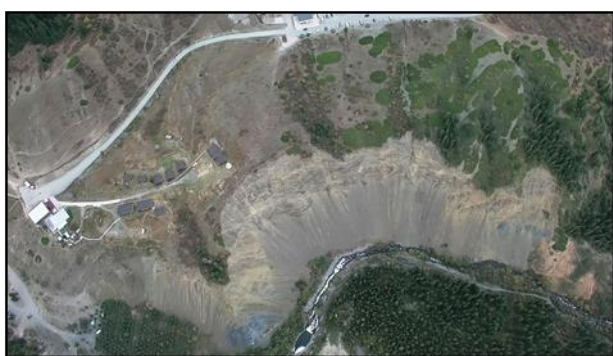
Conclusions on the stability of the left side of the valley of the river. Kolsai in the investigated area (Figures 5,6.).

1. Slopes are in an unstable state. According to preliminary calculations, the stability coefficient varies within 0.2...0.7 (upper escarpments and scree).

2. The surface of the slopes is undocked. Vegetation was noted only on the surface of the side of the gorge behind the edge of the canyon with a thickness of 30 cm.

3. Numerous water-erosional cuts of temporary action of various scales of manifestation on the surface of slopes are revealed, the development of which deforms the structure of slopes and worsens their bearing capacity as a basis for any structures. In addition, such cuts, as a result of backward erosion, deform even the turfed surface of the blockage itself.

4. There is a constantly changing technogenic load (buildings, structures, vehicles). At the same time, many of them are located almost along the edge of the slopes of the left side of the Kolsai river valley.

5. Uncontrolled saturation of the body of the dam with water of technogenic genesis (water supply, sewage drains) was revealed.

Figure 5. Portside (picture from UAV)

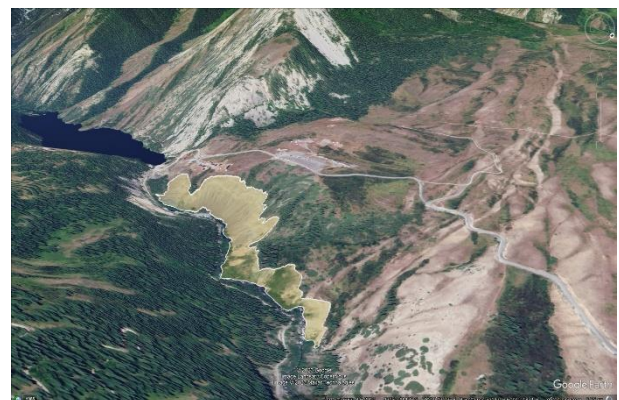
Figure 6. Contours of the left side of the Kolsai River. (contour perimeter ≈ 2.55 km contour area ≈ 7.9 ha)
